Flood Control Project Maintenance
2010 Structure Summary Report
Overall Unit and Item Ratings

Reclamation District No. 2063 Crows Landing

Reclamation District No. 2063 Pumping Plant (Nelson Drain)

Pumping Plant Rating	M
Date of Inspection	9/9/2010
DWR Inspector	David Pesavento
Accompanied By	Joe Sallaberry RD 2063

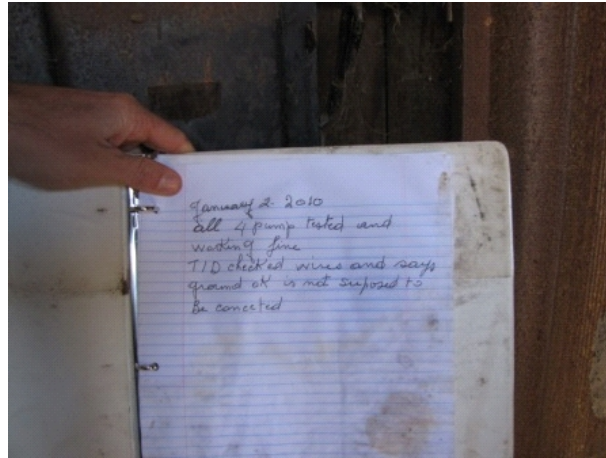
Levee Mile Report Line	1
Start Levee Mile	0.00
End Levee Mile	0.00
Location	
Category	Pump Stations
Item	Operating Log

View of the operation and maintenance log.

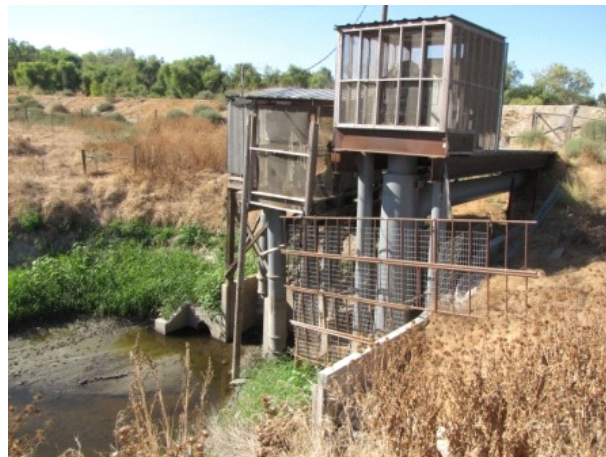
Levee Mile Report Line	3
Start Levee Mile	0.00
End Levee Mile	0.00
Location	
Category	Pump Stations
Item	Plant Building

View of plant and channel from the north-east.

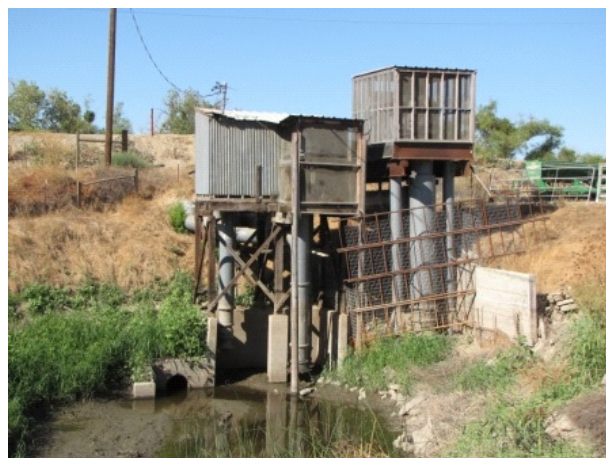
Levee Mile Report Line	3
Start Levee Mile	0.00
End Levee Mile	0.00
Location	
Category	Pump Stations
Item	Plant Building

View of the plant and channel from the east.

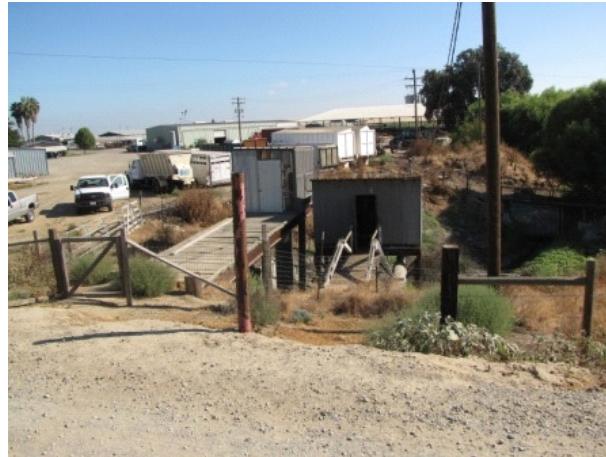
Levee Mile Report Line	3
Start Levee Mile	0.00
End Levee Mile	0.00
Location	
Category	Pump Stations
Item	Plant Building
View of the plant from the levee looking east.	
dpesaven_t_20100909_168.jpg

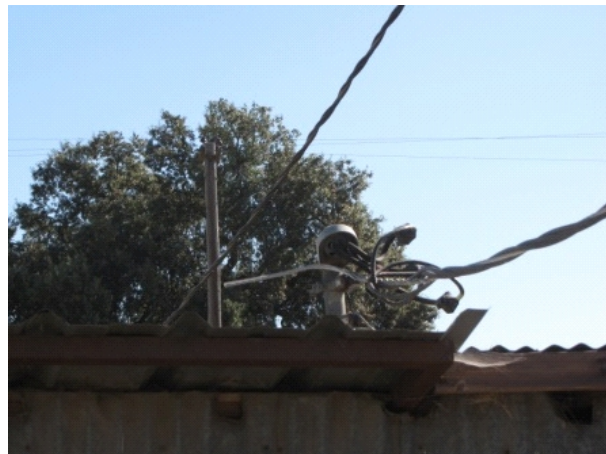
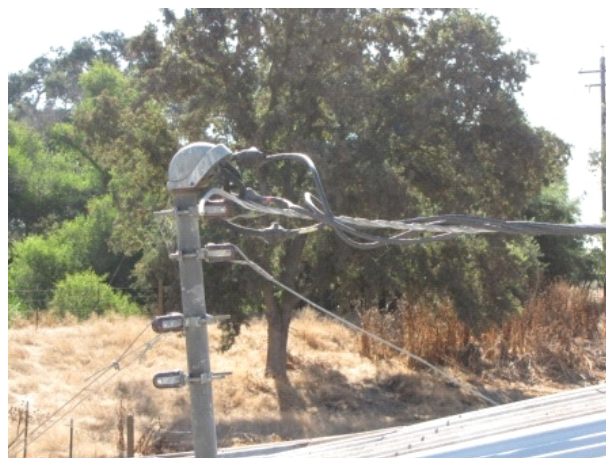
5	0.00	0.00	Pump Stations	Safety		M	Inspector Comments: Part of the power supply has become loose. The wires supplying power to the station could be stressed and separate. TID has refused to repair to date, inspector will contact and attempt to get it repaired.	37.431068 ° -121.011732 °	37.431068 ° -121.011732 °	Y	5
6	0.00	0.00	Pump Stations	Cranes		N	Inspector Comments: There is no crane at this plant.	37.431068 ° -121.011732 °	37.431068 ° -121.011732 °		6
7	0.00	0.00	Pump Stations	Pumps		A	Item inspected visually only. Item was not operated during the inspection. Inspector Comments: The pumps appeared to be well maintained and 3 of the four pumps were operated during the inspection. Keys were not available to conduct a thorough inspection of the fourth pump.	37.431068 ° -121.011732 °	37.431068 ° -121.011732 °	Y	7
8	0.00	0.00	Pump Stations	Power		A	Item inspected visually only. Item was not operated during the inspection. Inspector Comments: The power supply is generally reliable. TID should do maintenance on the power riser above the plant building as noted in the safety issue..	37.431068 ° -121.011732 °	37.431068 ° -121.011732 °	Y	8

Levee Mile Report Line	5
Start Levee Mile	0.00
End Levee Mile	0.00
Location	
Category	Pump Stations
Item	Safety
View of the electrical service connection to the station with the loose ground wire.	
dpesaven_t_20100909_169.jpg

Levee Mile Report Line	5
Start Levee Mile	0.00
End Levee Mile	0.00
Location	
Category	Pump Stations
Item	Safety
Additional view of the electrical service connection to the plant.	
dpesaven_t_20100909_170.jpg

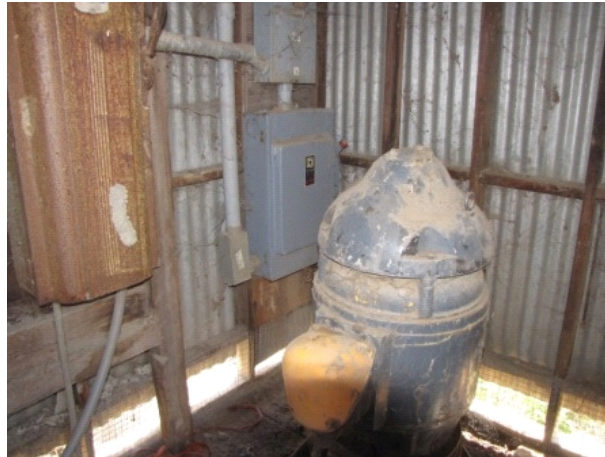
Levee Mile Report Line	7
Start Levee Mile	0.00
End Levee Mile	0.00
Location	
Category	Pump Stations
Item	Pumps

View of one of the pumps with control panels in the background.

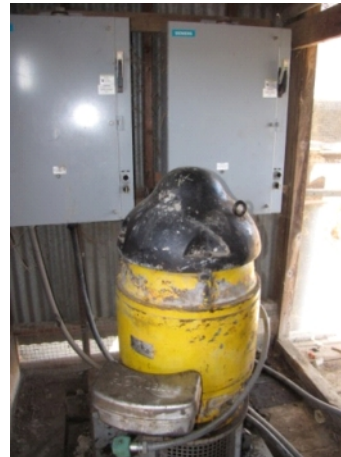
Levee Mile Report Line	7
Start Levee Mile	0.00
End Levee Mile	0.00
Location	
Category	Pump Stations
Item	Pumps

View of another pump with newer control panels behind.

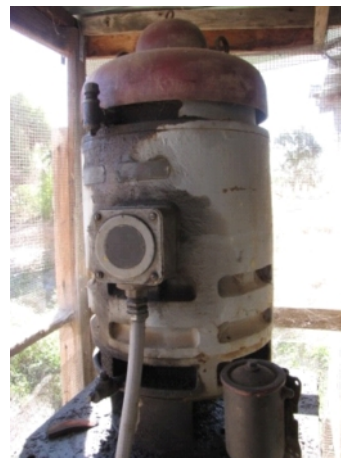
Levee Mile Report Line	7
Start Levee Mile	0.00
End Levee Mile	0.00
Location	
Category	Pump Stations
Item	Pumps

View of another pump.

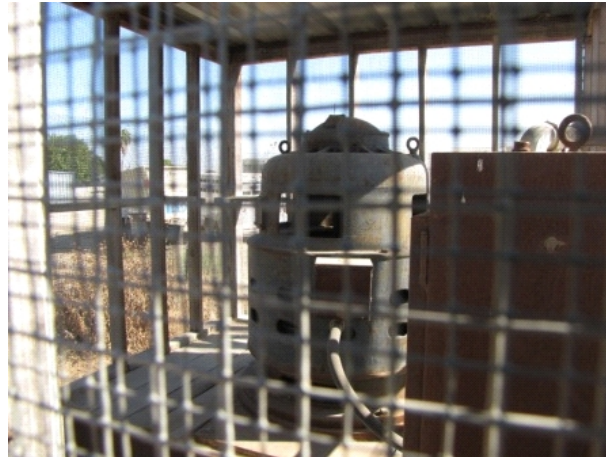
Levee Mile Report Line	7
Start Levee Mile	0.00
End Levee Mile	0.00
Location	
Category	Pump Stations
Item	Pumps
View of another pump in a separate room with the control panel in the foreground.	
dpesaven_t_20100909_184.jpg

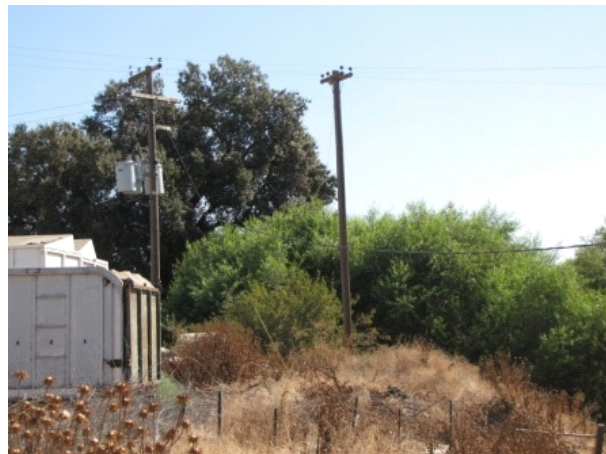
Levee Mile Report Line	8
Start Levee Mile	0.00
End Levee Mile	0.00
Location	
Category	Pump Stations
Item	Power
View of the electrical service and transformer.	
dpesaven_t_20100909_171.jpg

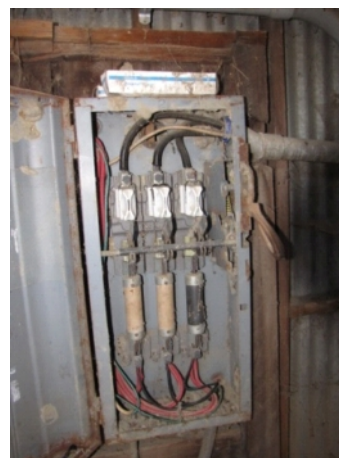
Levee Mile Report Line	10
Start Levee Mile	0.00
End Levee Mile	0.00
Location	
Category	Pump Stations
Item	Pump Control Systems
View of one of the control panels.	
dpesaven_t_20100909_172.jpg

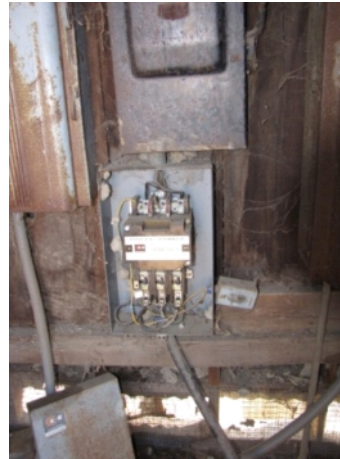
Levee Mile Report Line	10
Start Levee Mile	0.00
End Levee Mile	0.00
Location	
Category	Pump Stations
Item	Pump Control Systems

View of another electrical/control panel.

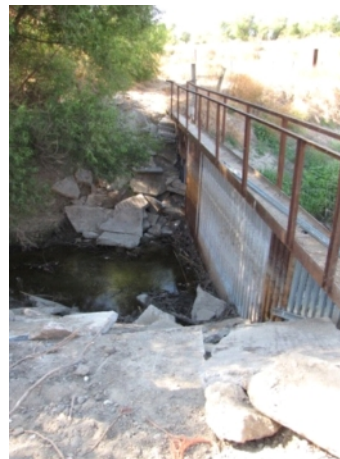
Levee Mile Report Line	12
Start Levee Mile	0.00
End Levee Mile	0.00
Location	
Category	Pump Stations
Item	Trash Racks

View of the channel side of the trash rack for the plant. Note the recently placed concrete protection and steel vertical members of the trash rack.

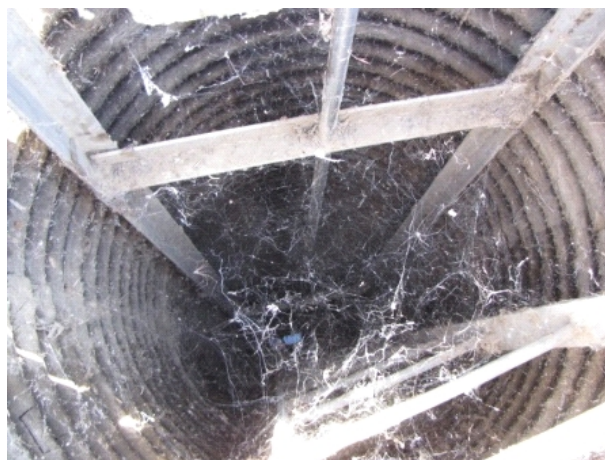
Levee Mile Report Line	14
Start Levee Mile	0.00
End Levee Mile	0.00
Location	
Category	Pump Stations
Item	Sluice / Slide Gates

View of the riser for the sluice gate. A clear view of the sluice gate is obstructed by spider webs.

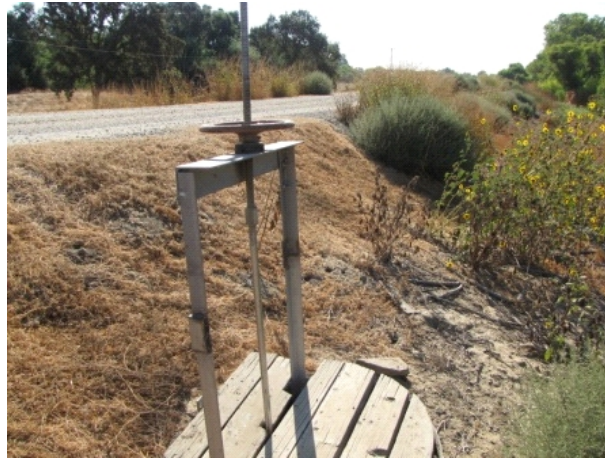
Levee Mile Report Line	16
Start Levee Mile	0.00
End Levee Mile	0.00
Location	
Category	Pump Stations
Item	Manual Gate Operators

View of the sluice gate operator.

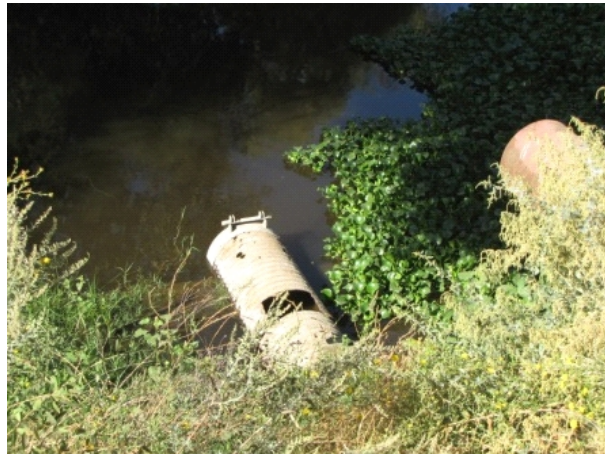
Levee Mile Report Line	18
Start Levee Mile	0.00
End Levee Mile	0.00
Location	
Category	Pump Stations
Item	Flap Gates

View of the gravity discharge outlet.

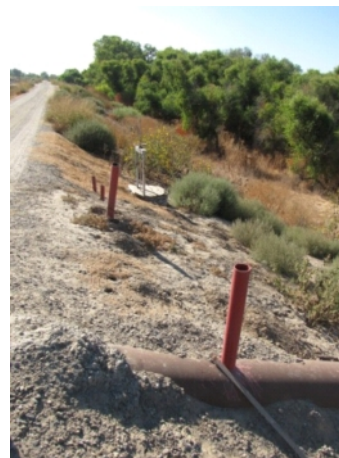
Levee Mile Report Line	21
Start Levee Mile	0.00
End Levee Mile	0.00
Location	
Category	Pump Stations
Item	Intake and Discharge Pipes

View of the discharge pipe vents acting as vacuum breakers.

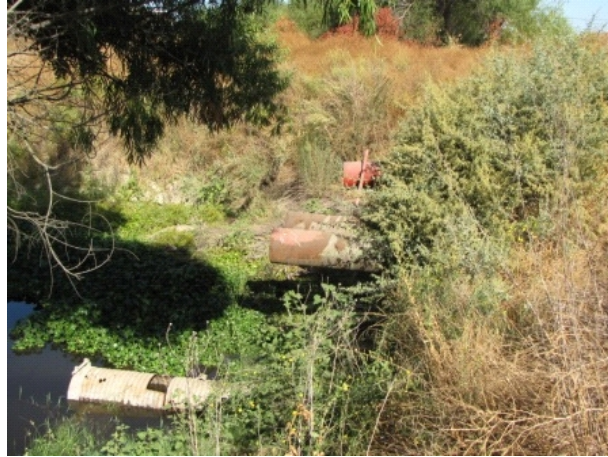
Levee Mile Report Line	21
Start Levee Mile	0.00
End Levee Mile	0.00
Location	
Category	Pump Stations
Item	Intake and Discharge Pipes

View of the discharge ends of the outlet pipes.

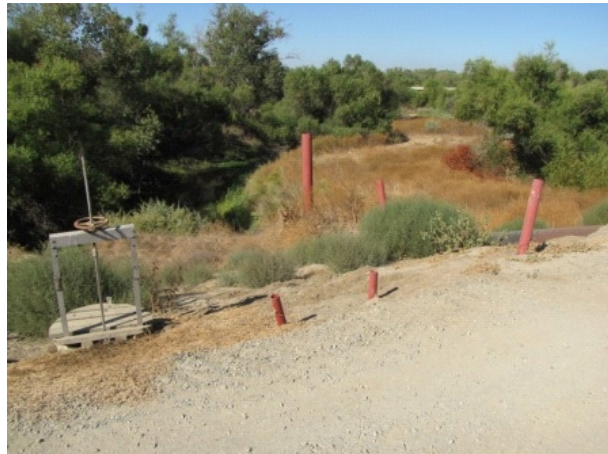
Levee Mile Report Line	21
Start Levee Mile	0.00
End Levee Mile	0.00
Location	
Category	Pump Stations
Item	Intake and Discharge Pipes

View of the waterward side of the levee with the vents visible.

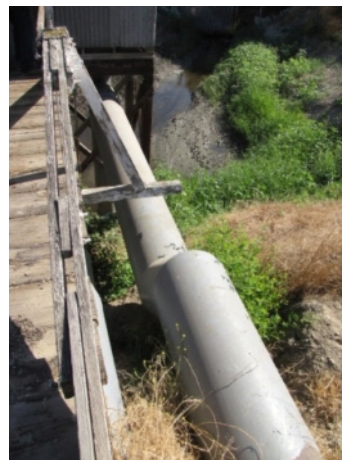
Levee Mile Report Line	22
Start Levee Mile	0.00
End Levee Mile	0.00
Location	
Category	Pump Stations
Item	Pressurized Pipe

View of one of the pipes from the pumps.

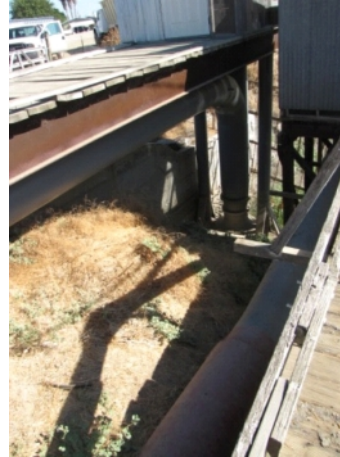
Levee Mile Report Line	22
Start Levee Mile	0.00
End Levee Mile	0.00
Location	
Category	Pump Stations
Item	Pressurized Pipe
View of two of the pipes from the pumps.	
dpesaven_t_20100909_186.jpg
